PIT Tag Information System

Newsletter

November 2007
Volume 8
Issue 1

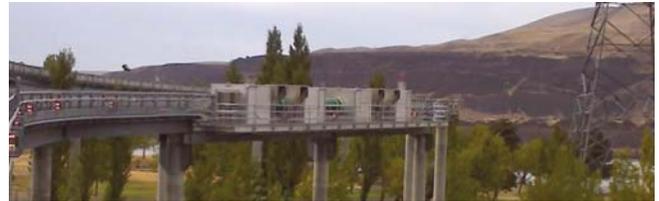
Figure 4 - John Day After Full Flow

There are four antennas in the Full Flow detection system at the John Day juvenile fish bypass.

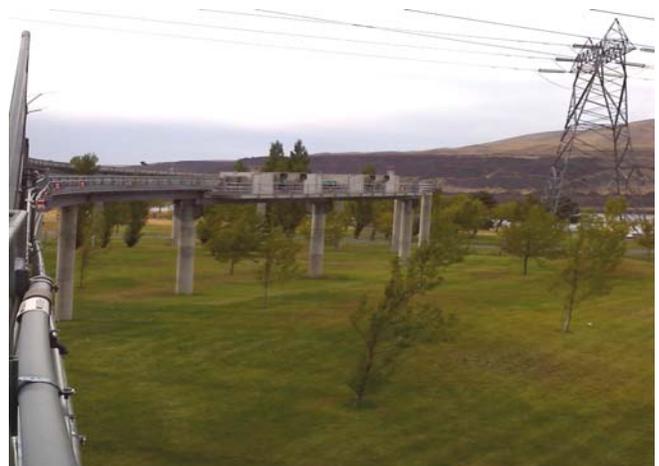
Figure 5 - John Day After Full Flow wide view

The John Day Full Flow system is elevated about 75 feet above the ground.

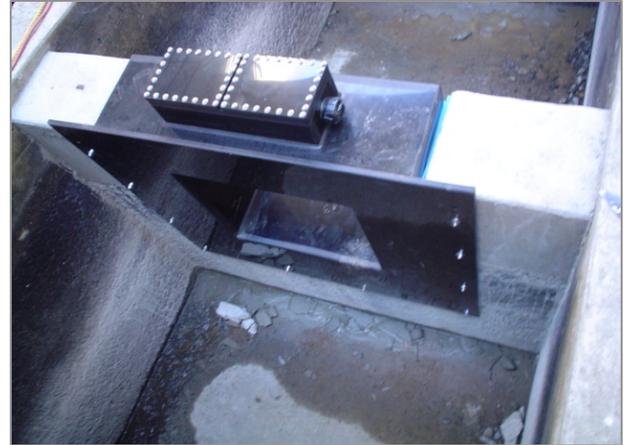
Figure 1 - A close-up of one of the PIT tag antennas installed in the fish ladder at Roza Dam.

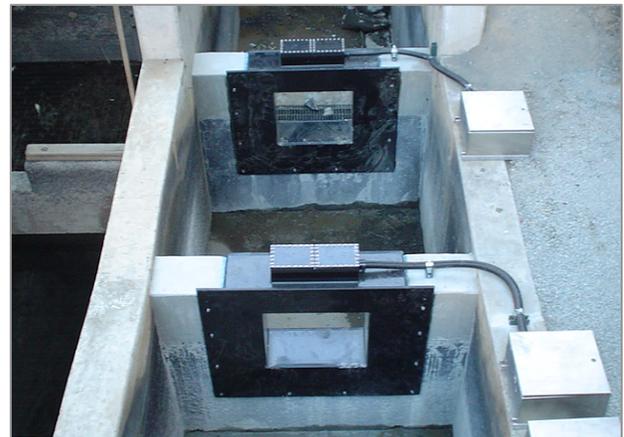
Figure 2 - All fish ascending the ladder must pass through these antennas.

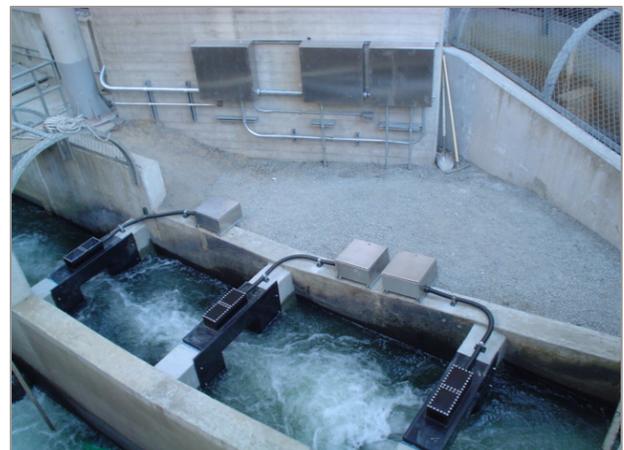
Figure 3 - There are three antennas, in adjacent weirs, in the adult ladder at Roza Dam.

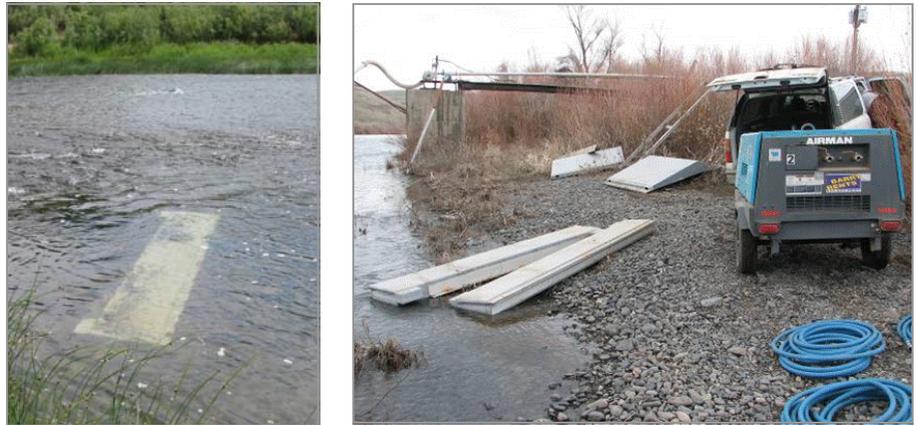
Figure 2. Installation and monitoring of the non-functioning antennas at the John Day River site.

Through hard work, we developed antennas that were 25' by 4' long, but for ease of installation purposes, we fabricated 20' by 2.5' long antennas. The other concern was whether we could hold the antennas in place during the spring runoff period. To test this, we hired a hydraulic firm to analyze the forces on the antennas and installed some non-functioning antennas into the river (Figure 2). Unfortunately, the spring runoff was minimal this year, but the hydraulic analysis indicated that the antenna housings would be held in place against normal spring flow conditions. Based on the analysis and observation of the river, we decided on using pass-by or flat plate antennas as the antenna design that would hold best in this river.

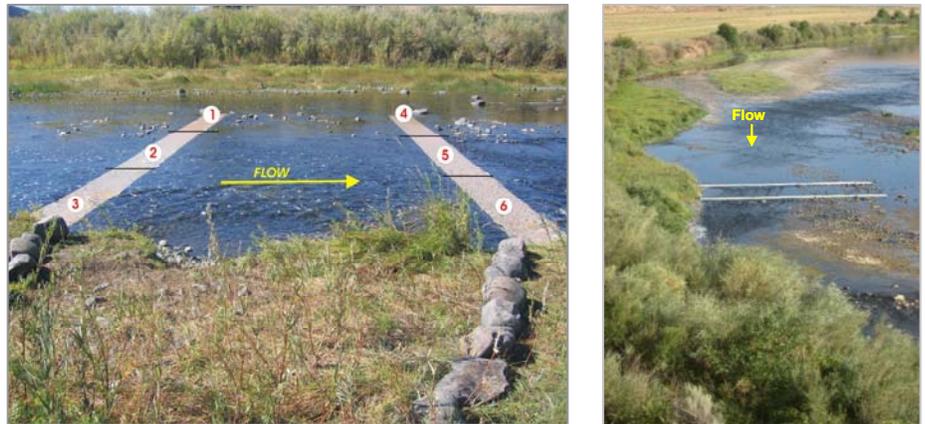
Figure 3. Photos showing the six antennas in the two 3-antenna array configuration

The two-array design will provide directional information on the fish detected on both arrays. The river is too wide for six antennas to cover the entire span completely when it is full of water and so we designed the system to cover the thalweg portion of the river.

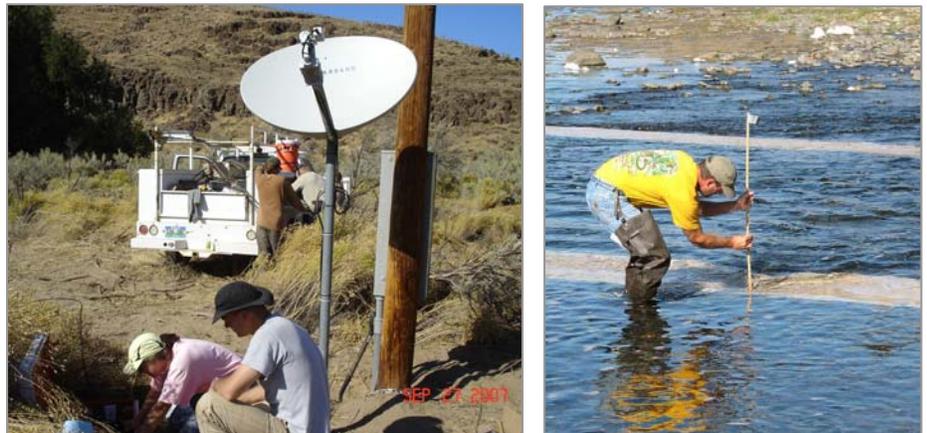
Figure 4. Photos showing work being done during the installation at the John Day River site (JD1). On the right, Steve Anglea is taking tag-reading measurements on one of the antennas.

The AC power, data collection, and the communication systems were installed on 27 September for the new JD1 site (Figure 4).

Biomark installed the permanent MUX transceiver on 2 October when they conducted tag-read-range tests (Figure 4). The AC power, data collection, and the communication systems were installed on 27 September for the new JD1 site (Figure 4). Biomark determined that the system could read the new SST model PIT Tags consistently at 18" vertically from the antennas and ST tags at 12"-15". Being able to read the ST tags at that height is important because many of the adults returning over the next few years would have been tagged with ST tags as juveniles.

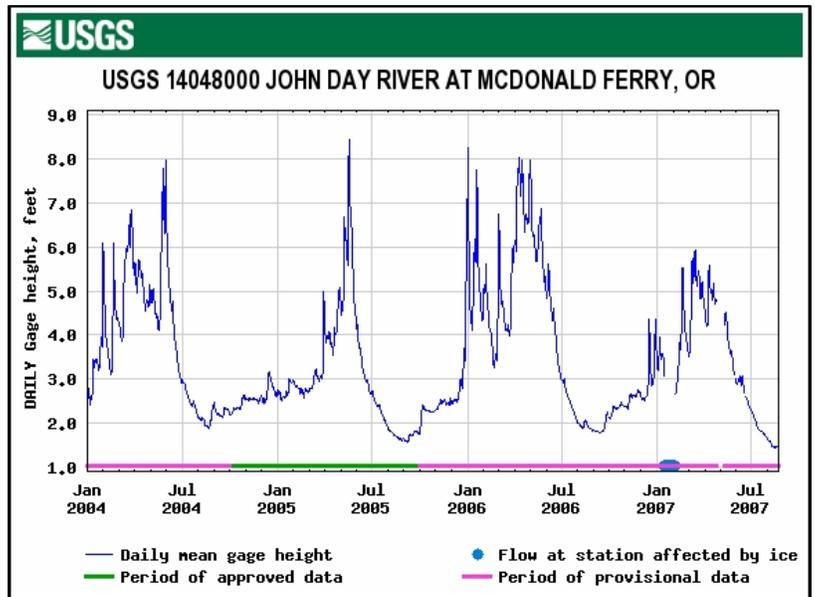
Figure 5. Water depth values from the USGS gauge at McDonald Ferry (January 2004 - July 2007).

The water depth when the steelhead are migrating during the fall to early winter ranges from 1.5-3.0 feet at this section of the John Day River (Figure 5). With these depths and if, as people predict, the fish stay near the bottom of the river and within the thalweg where we installed the equipment, then we think we will be able to detect most of the migrating fish. In 2008, we plan to determine the detection efficiency of the system using steelhead double-tagged with PIT and radio tags.

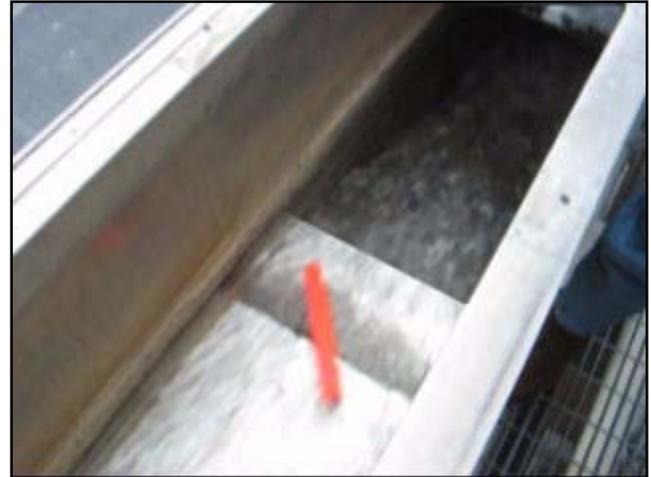
Figure 1 - A PTAGIS diagnostic test (stick) tag activating a typical slide gate.
